Inspection Report Minerals Regulatory Program

Mine Name: Desert Sienna	Permit numbe (unpermitted)	er: S/015/09)3
Operator Name: Bown Stone Products	Inspection Da Time: About	•	
Inspector(s): Paul Baker Other Participants: Rebecca Doolittle, Price BLM Mine Status: Unpermitted	Weather: Cle	ear, 30's, a li	ttle snow on
Elements of Inspection	Evaluated	Comment	Enforcemen
 Permits, Revisions, Transfer, Bonds Public Safety (shafts, adits, trash, signs, highwalls) Protection of Drainages / Erosion Control Deleterious Material Roads (maintenance, surfacing, dust control, safety) Concurrent Reclamation Backfilling/Grading (trenches, pits, roads, highwalls, shafts, drill holes) Water Impoundments Soils Revegetation Air Quality Other 			
Purpose of Inspection: We wanted to see where this site is and to see what the conditions are like.

S/015/083, Desert Sienna Mine, Bown Stone Products

Inspection Dated: January 20, 2006; Report Dated: February 8, 2006

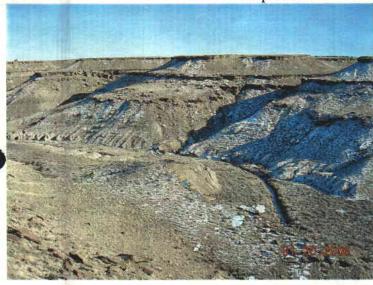
This site is located at the Molen Seep east of Ferron, an area I had not previously visited in over a hundred trips to Emery county. The "seep" is a small canyon (Photos 1 and 4) with a sandstone rim. Surrounding areas are relatively flat with a little soil over the sandstone bedrock. There is a pinyon/juniper vegetation community on the plateau, but the trees are widely spaced (Photo 2).

Photo 1. Molen Seep. We did not look closely at the channel, but based on the nature of the channel, I suspect it has flowing water much of the year.

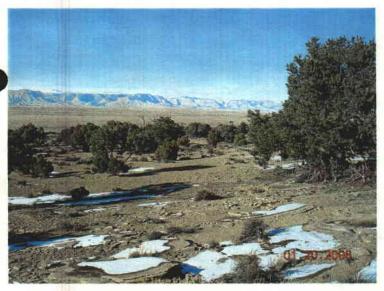
Photo 2. The plateau above the canyon.

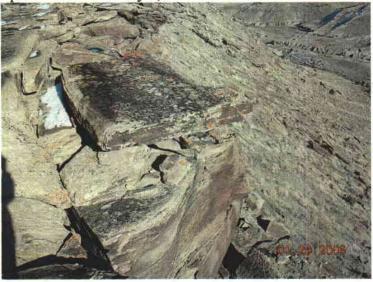
Photo 3. Rimrock at the edge of the canyon.

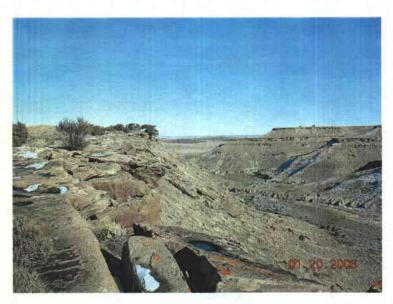
Photo 4. Another view of the edge of the canyon.

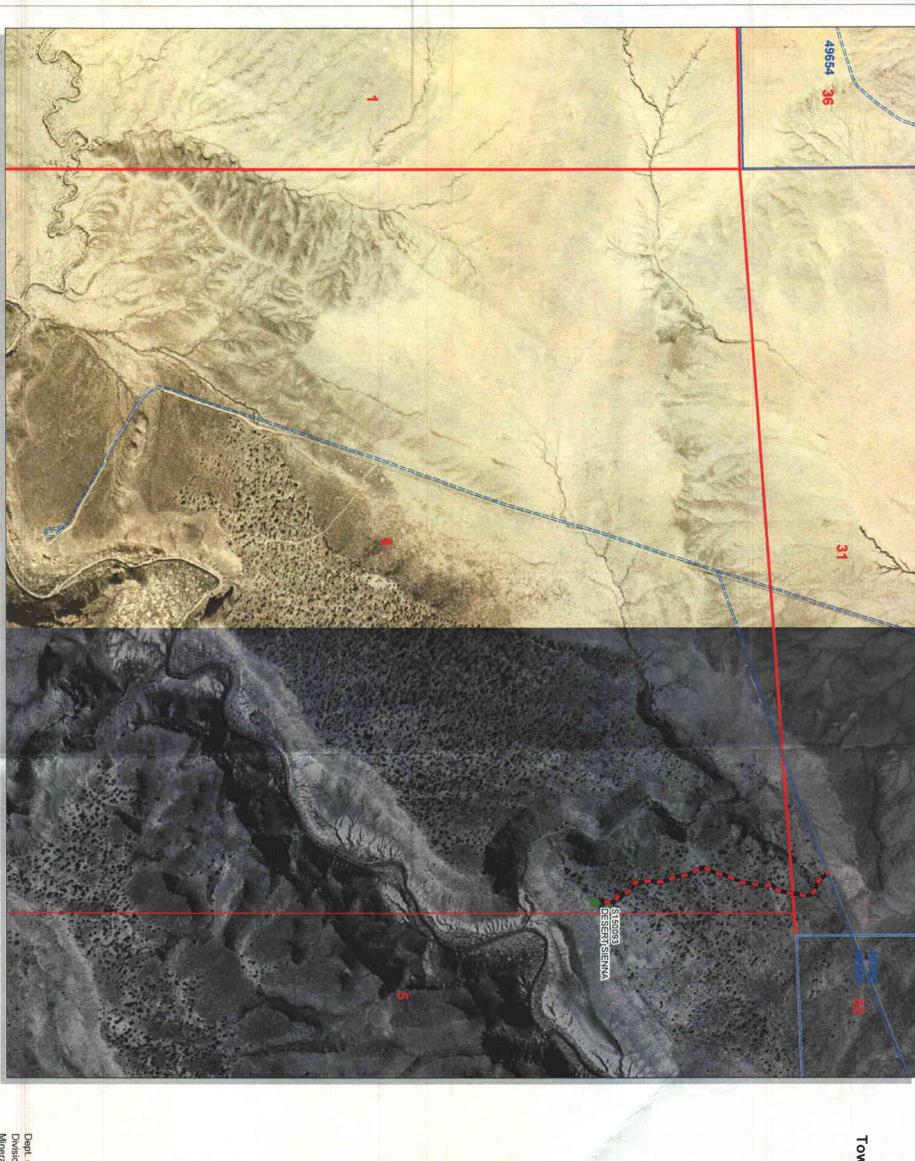
ownship 21 S Range 08 E Section 06 SLBM Mine Name: Desert Sienna Mine Number: S0150093

There is an existing road to within a few hundred yards of the edge of the canyon, and there is something of a two-track road that winds through the trees to near the canyon (see the attached map). This two track road will need to be included as part of the disturbed area. The operator intends to

make some modifications to the existing east-west road, and these modifications will also need to be part of the disturbed area.
